# Other Causes of Fastener Failures

Carrie Menendez  
Failure Metallurgist  
Stork Materials Testing & Inspection (SMT&I)  
15062 Bolsa Chica  
Huntington Beach, CA 92649 USA  
www.storksmti.com

There are failure mechanisms other than fatigue, hydrogen embrittlement, stress corrosion cracking and overload that must be dealt with by fastener makers.

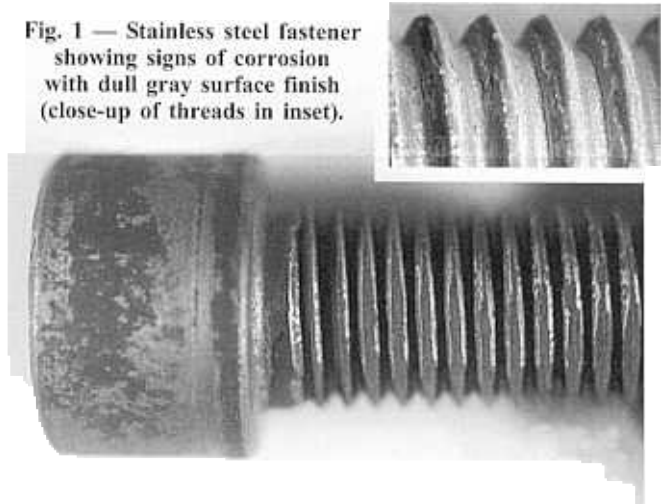
After passivation it was noticed that the samples appeared corroded or attacked, with a dull gray surface finish (as seen in Figure 1) that felt slightly gritty to the touch. The failure analysis group was asked to determine the cause of the problem. In this case, the fastener had not been in service, therefore the problem was limited to a manufacturing problem, a heat treating problem or a passivation process problem.

Fig. 1 — Stainless steel fastener showing signs of corrosion with dull gray surface finish (close-up of threads in inset).

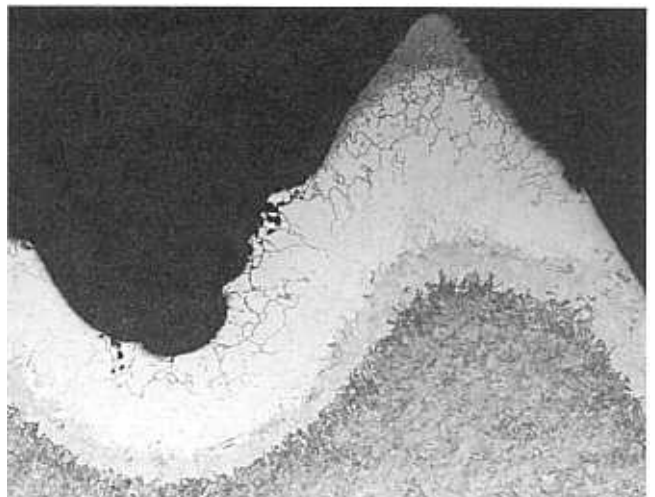
layer (as seen in Figure 2) along the surface of the fastener that was found to be reverted austenite. The corrosion of this white layer was visible in several areas of the examined fastener.

Past analyses performed at SMT&I have found that reverted or retained austenite exhibits a much lower resistance to corrosive-type attack than the surrounding martensitic structure. The presence of such a non-uniform layer of reverted austenite is typically the result of nitrogen pick-up during heat treatment of the fastener and is commonly associated with a contaminated furnace atmosphere.

Fig. 2 — Reverted austenite layer layer on fastener (magnification 50X).

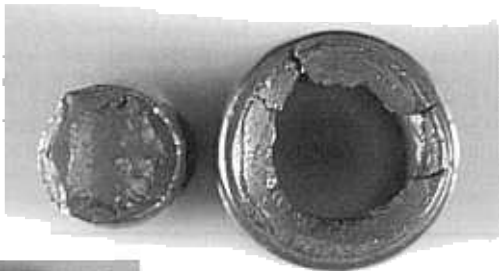
Several aluminum toe bolts were submitted to SMT&I personnel to determine the cause of crack indications/bursts visible on the point end of the bolts (Figure 3) from two groups. One of the submitted groups of toe bolts did not exhibit any obvious indications of defects and was to be used as a control or comparison group of samples. Sectioning one of the "bad" bolts resulted in the core material falling out of the threaded portion as though the threads were a sleeve or a shell (as seen in Figure 4).

Fig. 3 — Cracks & burst visible on point end of bolts.

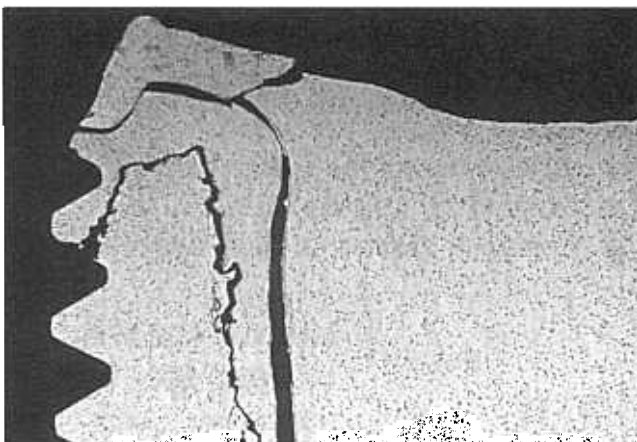
Longitudinal and transverse cross sections through bad bolts were mounted in Bakelite and polished to a metallurgical finish. Examination of the samples in the as-polished and etched conditions revealed clear evidence of a path of segregated inclusions and/or bursts throughout the threaded section of the fasteners (as seen in Figure 5) as well as into the forged

Fig. 5 — Path of segregated inclusions & bursts throughout threaded section of fastener (magnification 15X).

head. The inclusions and/or bursts were found to follow the contour of the head, suggesting that the bursts were created or accentuated during the forging process. In the transverse orientation, the segregation of inclusions was distinctly visible surrounding the path of the bursts in the toe bolt material.

Aside from the variation in material and tensile strength from the reported information or drawing information, the presence of such segregation of inclusions within the material would be problematic. It could not be determined, however, if the forging bursts were related to the variation in material properties/improper material. For instance, if a more severe force is used to forge AA 2024 T4 material than would be used for AA 6061 T6, then it is conceivable that the bursts may not have been present if the appropriate forging conditions were used for the material actually used to make the bolts. However, the segregation of inclusions is not related to the forging of the bolts. Rather, it is associated with the wire or bar stock used to make the fastener blanks. Therefore in this case, two types of failure mechanisms contributed to the failures of the toe bolts. These were raw material defects (inclusion segregation) and manufacturing defects (forging bursts).

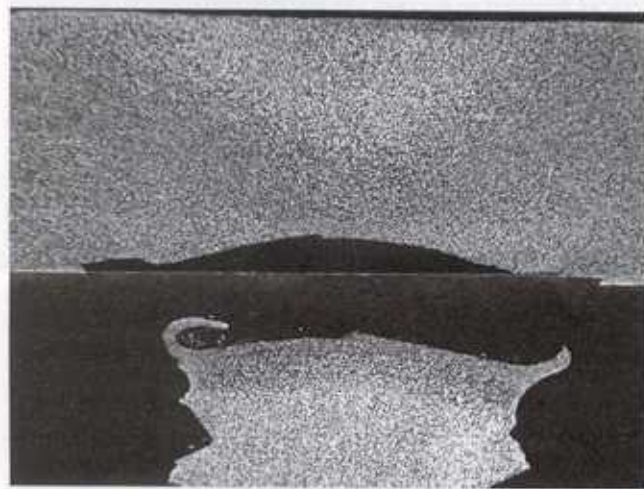
The etched sample revealed flow lines from the heading operation extending into the shank of the bolt, which is typically considered undesirable (see Figure 7 on the next page). Further examination of the etched cross section revealed the heavily deformed grain flow to be ori-

ented almost completely perpendicular to the axis of the bolt. The fracture path was found to follow the orientation of the grain flow from heading, resulting in the relatively flat and smooth fracture surface within the head of the bolt.

Typically, the intersection of the longitudinal axis of the fastener and transverse axis of the heading flow lines is at a distance of at least  $D/4$  from the bearing surface (in the head). In this hex bolt case, the location of this intersection was less than  $D/4$  from the bearing surface of the failed fastener.

Fig. 7 — Flow lines from the heading operation extending into the hex bolt's shank.

The failure in this case would most likely have been avoided had the heading grain flow pattern been isolated within the head of the fastener and not extended into the shank of the bolt, passing through the bearing surface of the bolt. This failure was classified as a manufacturing (a forging) problem.
